BY THE COMPTROLLER GENERAL

# Report To The Congress

## F/A-18 Naval Strike Fighter: Progress Has Been Made But Problems And Concerns Continue.

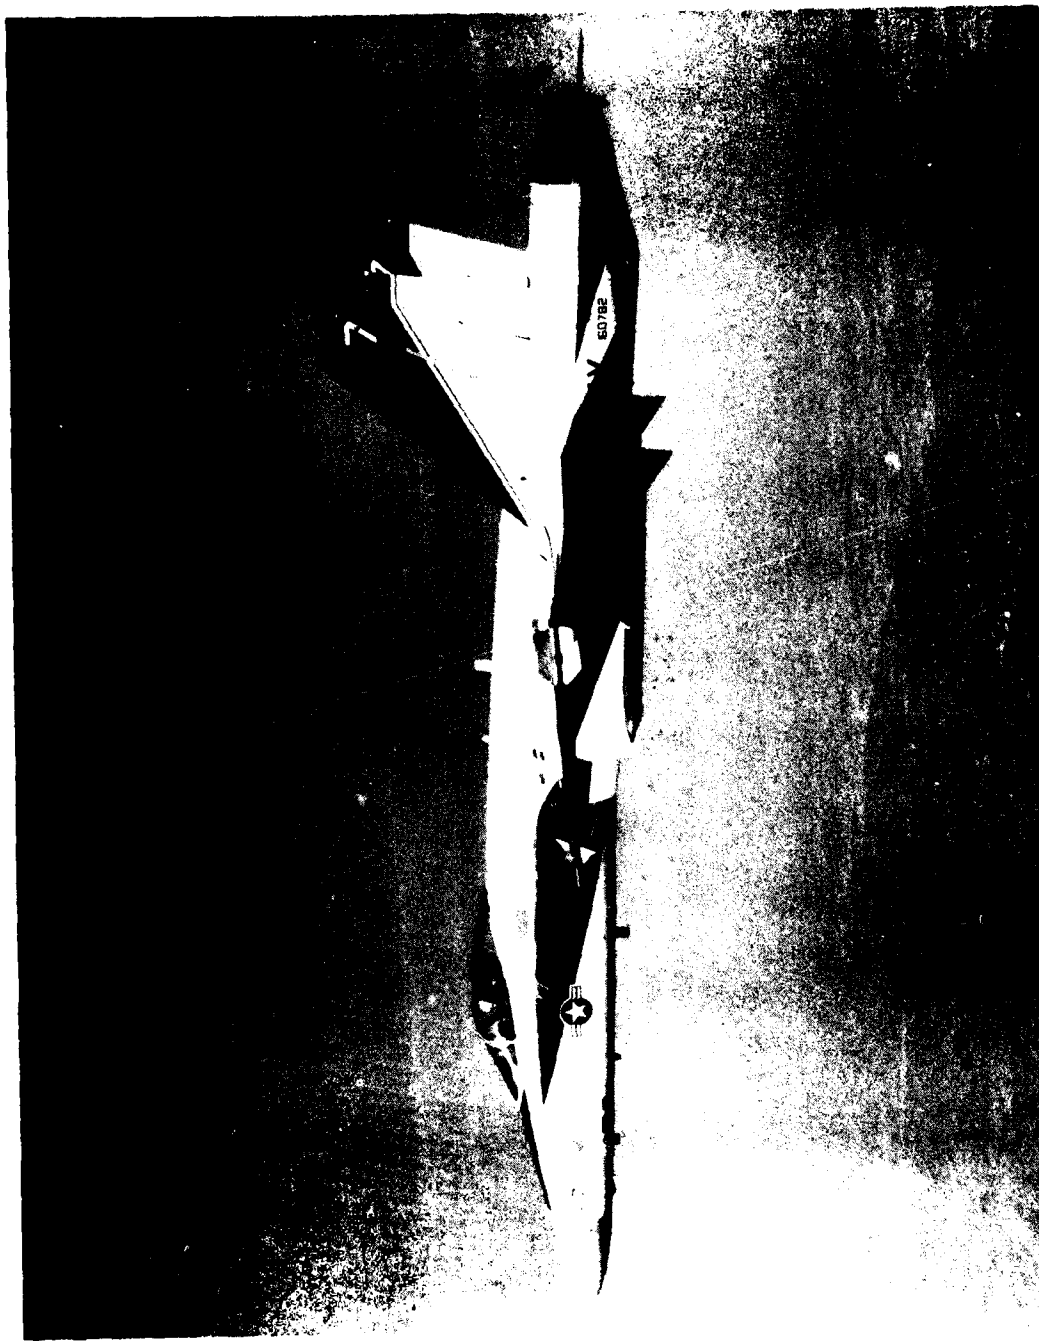
SOURCE: PHOTOGRAPH COURTESY OF McDONNELL DOUGLAS CORPORATION  
**F/A-18 NAVAL STRIKE FIGHTER**

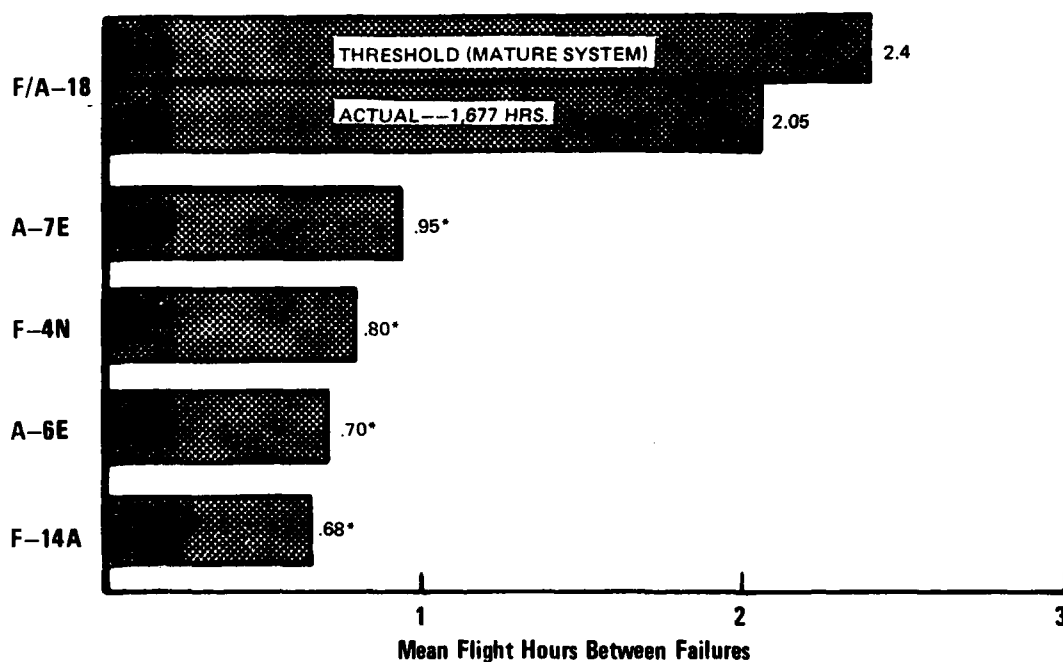
FIGURE 1  
RELIABILITY COMPARISON

The F/A-18's reliability in the full-scale development program compares favorably with that of the Navy's F-4, A-6, A-7, and F-14 operational aircraft based on data from the Navy's Maintenance and Materiel Management System as shown in figure 1.

\*BASED ON CALENDAR YEAR 1979 DATA
